NE NEW MEXICO HISTORIC BUILDING INVENTORY FORM - MISSION CHURCH SURVEY

Identification	building name(s) historico: MARIA SANTISIMA de CONCEPCION current: IMMACULATE CONCEPTION	county SAN MIGUEL	ID no. 1168	
	location description (including street *): IN CONCEPCION NEAR ROMERVILLE, EXIT 1-25 ON ROMERVILLE FOLLOW SOUTH FRONTAGE RD TO COUNTY RD C24, TURN SE AND FOLLOW ROAD 10.6 MILES TO CHURCH (GO THRU SAN AGUSTIN)	UTM reference easting northing	legal description TNSP 14 (N) S range 17 (E) W sec. 1/4 1/4	
	mailing address C/O Sr. & Sra. ROSENDO GONZALES 1017 TILDEN	field map NM Highway Dept Quad	name and number ANTON CHICO # 44	land grant/reservation LAS VEGAS
		city/town LAS VEGAS NM	zip 87701

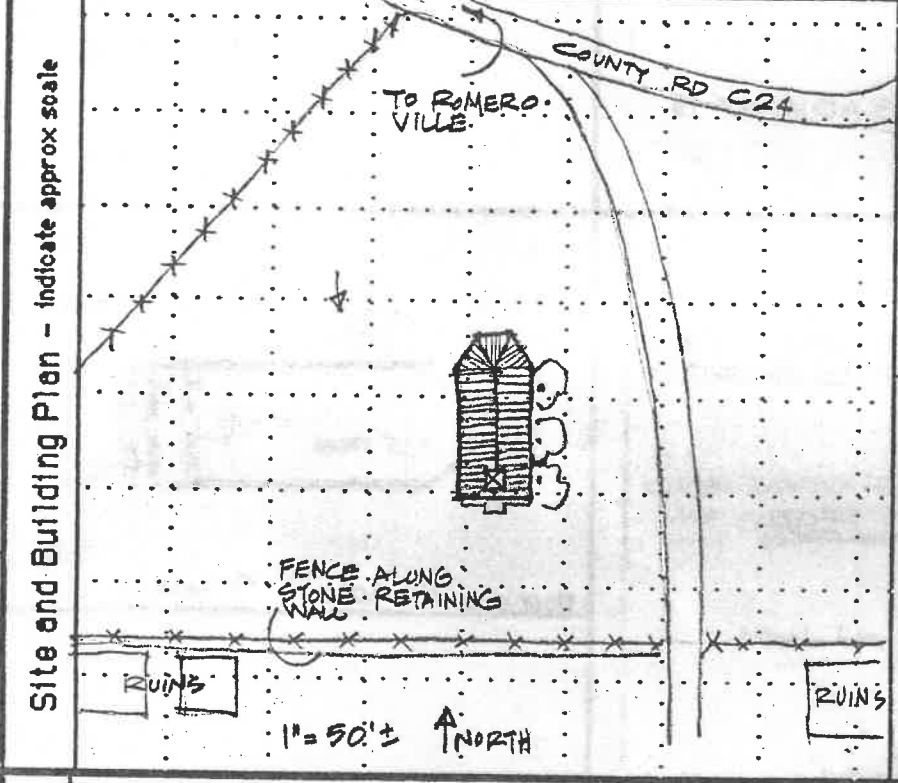
architectural features: • PITCHED ROOF W/ BELFRY. WOOD SHINGLES ON BELFRY • CHAIR LOFT • BARREL VAULT CEILING W/ 1/2 DOME ABOVE SANCTUARY • ALL FACED WITH 1X BOARD • CASSED ENTRY DOOR OPENING W/ TERRITORIAL STYLE TRIM	Condition: good _____ fair _____ deteriorating <u>X</u> comments: <u>NEEDS MAJOR REPAIRS TO RAFT, NEW CLOSURES</u> <u>AT ALL OPENINGS, AND REPAIRS TO WOOD FLOOR</u> <u>AND WALL SURFACES</u>	
	Is building threatened? <u>YES</u>

structure: ADOBE WALLS APPEAR SOUND BUT MUD PLASTER IS ERODING ON INSIDE AND OUTSIDE SURFACES

Other: openings: WINDOW SASH AND DOORS HAVE BEEN REMOVED

repair: ROOF COVERING NEEDS TO BE REPLACED. AND FRAMING REVIEWED FOR ADEQUACY
