**IMMACULATE CONCEPTION CHURCH  
CONCEPCION, NEW MEXICO**

**ROOF ASSESSMENT**

**FRANCISCO UVIÑA CONTRERAS**

May 1996

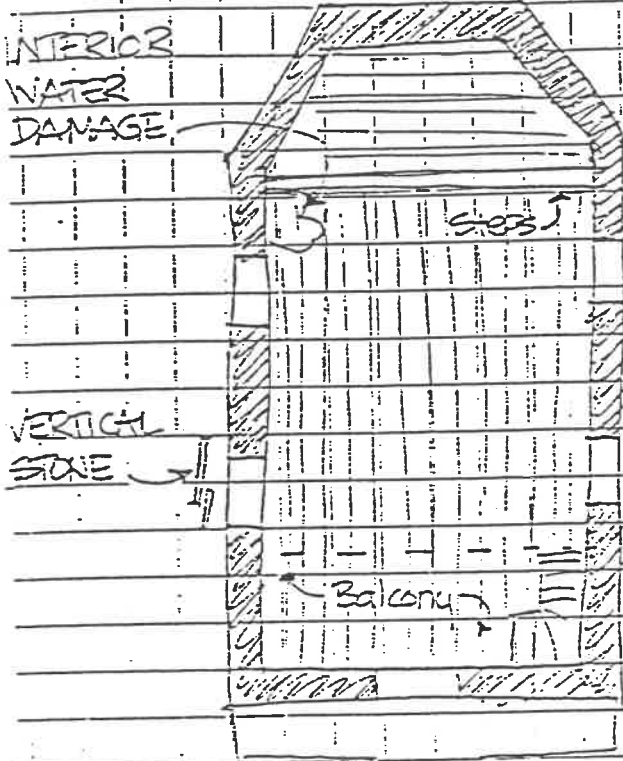
## BUILDING PLAN

INTERIOR  
WATER  
DAMAGE
