## San Miguel Chapel Preservation News

Cornerstones began our second year of preservation work at San Miguel Chapel by making a frightening discovery.

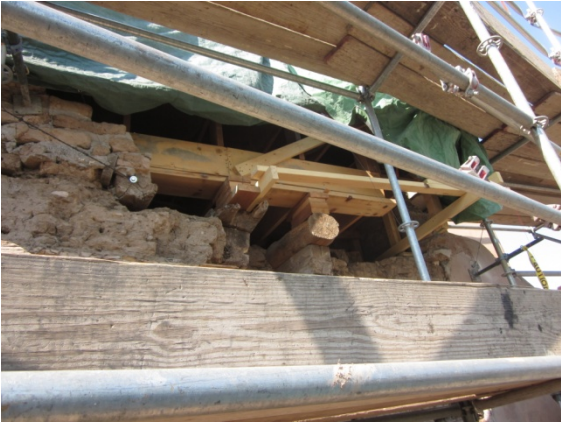
In removing the stucco on the north wall, we found that sometime in the past a large void had been filled with concrete and fired brick. The parapet resting on this section was in immediate danger - **we estimated that as much as 5 tons of material was hanging in the air at that location.**

Had that section collapsed it would have been catastrophic for the church as well as for the road below and any traffic or pedestrians. We immediately braced this parapet and over the course of several days installed timber bracing from the ground up. Once the bracing was in place we proceeded as carefully and as quickly as we could to remove the adobe parapet in this area. About 24' linear feet of parapet was removed in stair-step fashion, piece by piece. Work proceeded to remove adobe that had deteriorated, collapsed, cracked and/or crumbled.

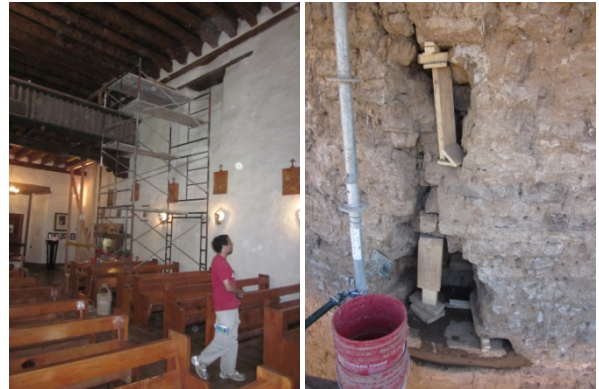
In the course of removing this adobe further concern arose about the capacity of this section to support the roof. In some areas we found ourselves right at the interior plasters. We proceeded to install shoring inside the church from the ground through the choir loft to the vigas above the choir loft. Once all this temporary bracing was in place work proceeded on reconstruction of the corner. The repair of the corner is being accomplished by careful structural stitching of new to old adobe using all 'in kind' materials of adobe bricks made on site and matching earthen mortar. No more than 3-4 lifts will be attempted at any one time so that the wall can dry thoroughly as it goes up.
