NE NEW MEXICO HISTORIC BUILDING INVENTORY FORM - MISSION CHURCH SURVEY

Identification	building name(s) historico: MARIA SANTISIMA de CONCEPCION current: IMMACULATE CONCEPTION	county SAN MIGUEL	ID no. 1168	
	location description (including street *): IN CONCEPCION NEAR ROMERVILLE, EXIT 1-25 ON ROMERVILLE FOLLOW SOUTH FRONTAGE RD TO COUNTY RD C24, TURN SE AND FOLLOW ROAD 10.6 MILES TO CHURCH (GO THRU SAN AGUSTIN)	UTM reference easting northing	legal description TNSP 14 (N) S range 17 (E) W sec. 1/4 1/4	
	mailing address C/O Sr. & Sra. ROSENDO GONZALES 1017 TILDEN	field map NM Highway Dept Quad	name and number ANTON CHICO # 44	land grant/reservation LAS VEGAS
		city/town LAS VEGAS NM	zip 87701

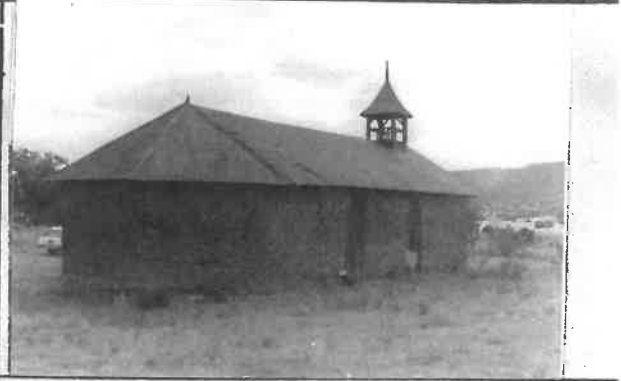
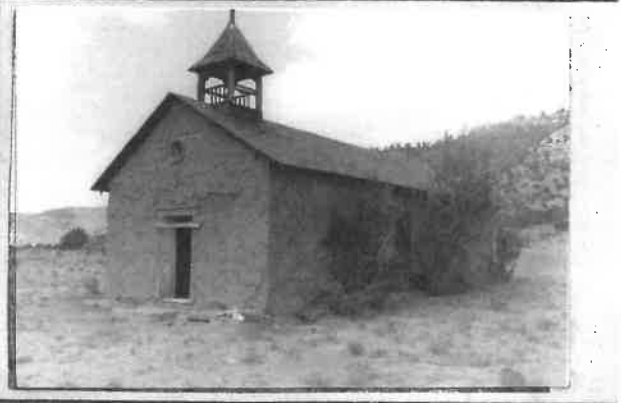
architectural features: • PITCHED ROOF W/ BELFRY. WOOD SHINGLES ON BELFRY • CHAIR LOFT • BARREL VAULT CEILING W/ 1/2 DOME ABOVE SANCTUARY • ALL FACED WITH 1X BOARD • CASSED ENTRY DOOR OPENING W/ TERRITORIAL STYLE TRIM	Condition: good _____ fair _____ deteriorating <u>X</u> comments: <u>NEEDS MAJOR REPAIRS TO RAFT, NEW CLOSURES</u> <u>AT ALL OPENINGS, AND REPAIRS TO WOOD FLOOR</u> <u>AND WALL SURFACES</u>	
	Is building threatened? <u>YES</u>

structure: ADOBE WALLS APPEAR SOUND BUT MUD PLASTER IS ERODING ON INSIDE AND OUTSIDE SURFACES

Other: openings: WINDOW SASH AND DOORS HAVE BEEN REMOVED

repair: ROOF COVERING NEEDS TO BE REPLACED. AND FRAMING REVIEWED FOR ADEQUACY
